**APPENDIX C**  
**Geotechnical Assessment of the Project Levees**

**RECONNAISSANCE REPORT  
SAN JOAQUIN RIVER MAINSTEM, CALIFORNIA**

**August 1992**

**PREPARED BY  
SOIL DESIGN SECTION**

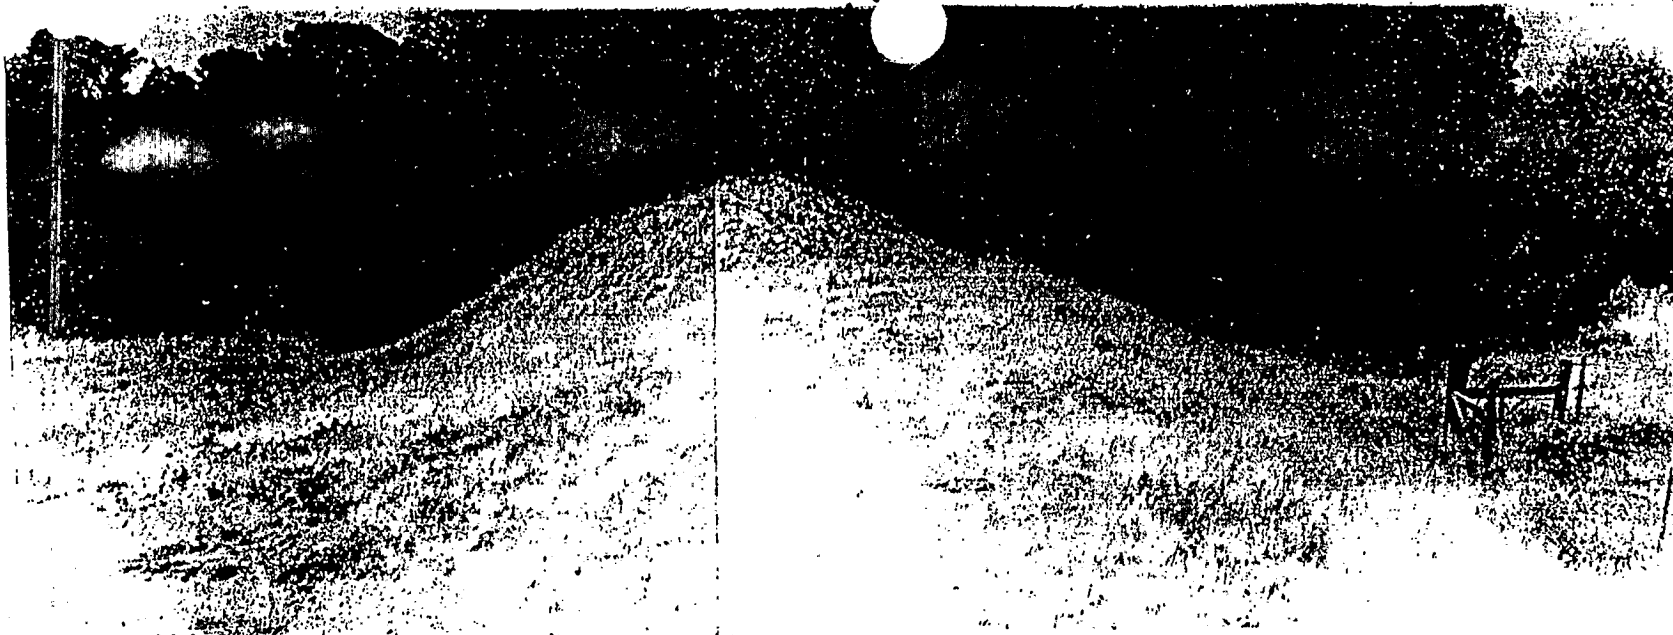
Photo 1

<u>RIVER MILE</u>	<u>BANK</u>	<u>R.D.</u>	<u>REACH</u>	<u>SOURCE</u>	<u>DESCRIPTION OF AREA</u>
133.6 - 133.7	Right	LSJLD	3	Field Ins.	Levee breach (Reported to be manmade for the purpose of draining rainwater back into the river system).

Photo 1: Levee breach on the right bank levee of the San Joaquin River  
at river mile 133.6, overgrowth vegetation at the breach.  
(Lower San Joaquin Levee District)  
(May 28, 1992)

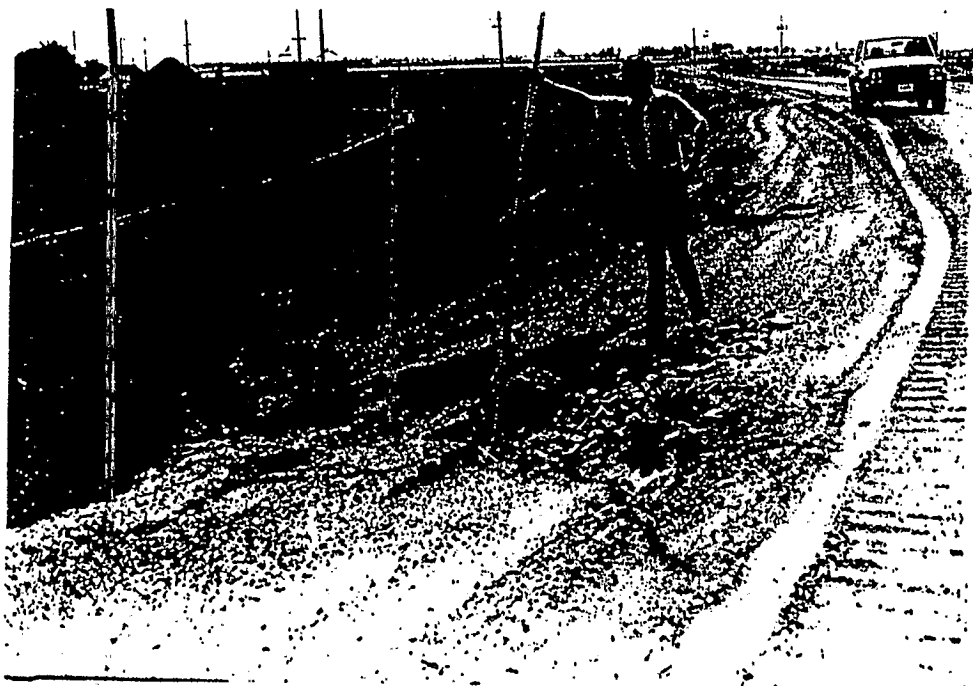
Photo 21

Photo 21: Levee erosion on the land  
side slope near river mile 60.8  
(Reclamation District No. 2095)  
(June 18, 1992)

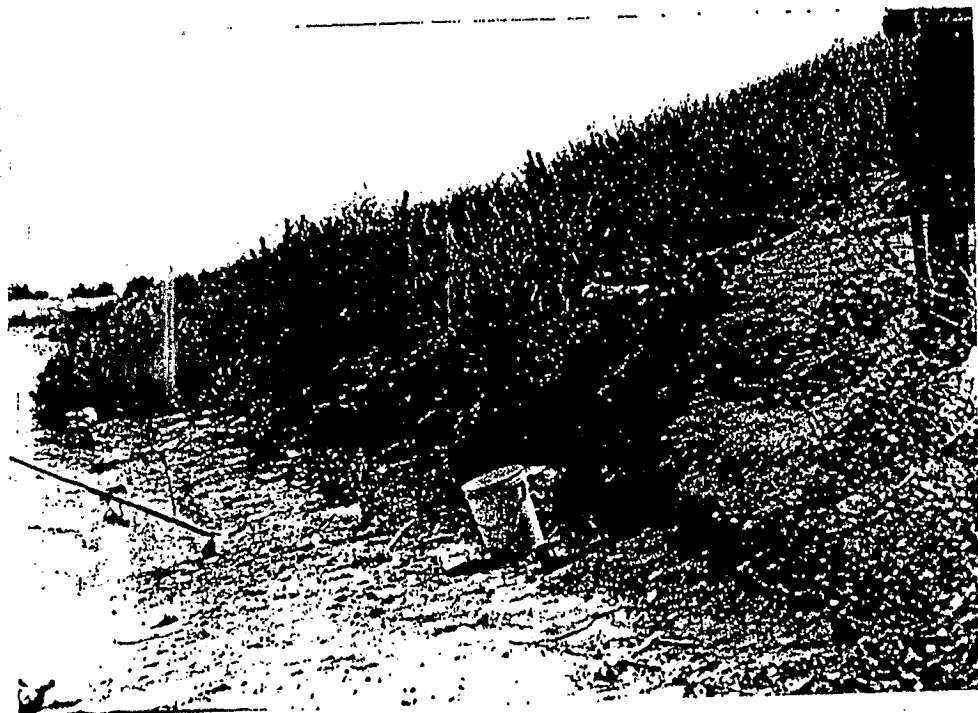
Photo 26

Photo 26: Erosion on the left bank of  
the San Joaquin River near  
river mile 53.8.  
(Reclamation District No. 2062)  
(June 18, 1992)
